# **ASBESTOS MANAGEMENT SURVEY REPORT**

**SAINSBURYS ARGOS**

**Argos (Leven), Unit 2, Riverside Retail Park, Riverside Road, Leven,  
Fife, KY8 4LT**

**101641-ARGOS818**

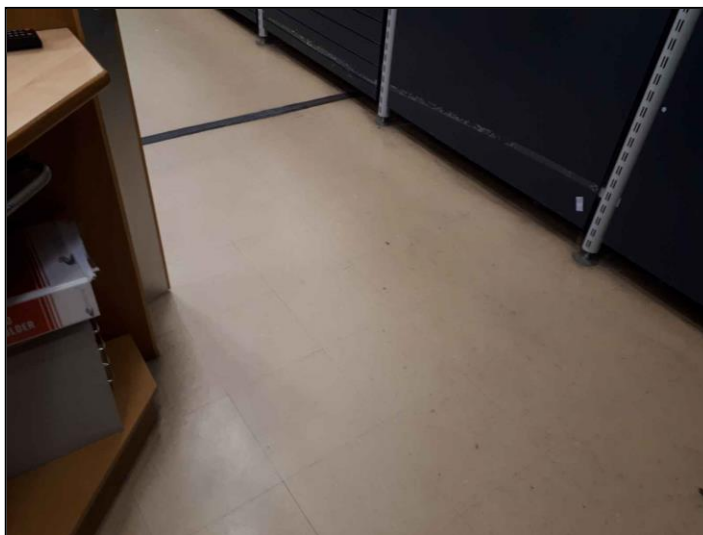
Asbestos Type: 0 - No asbestos detected

Sample No: AWS - 001

Approx Size of Item: 85 m<sup>2</sup>

Timescale for Recommendation : No action

Recommendation: No further action required

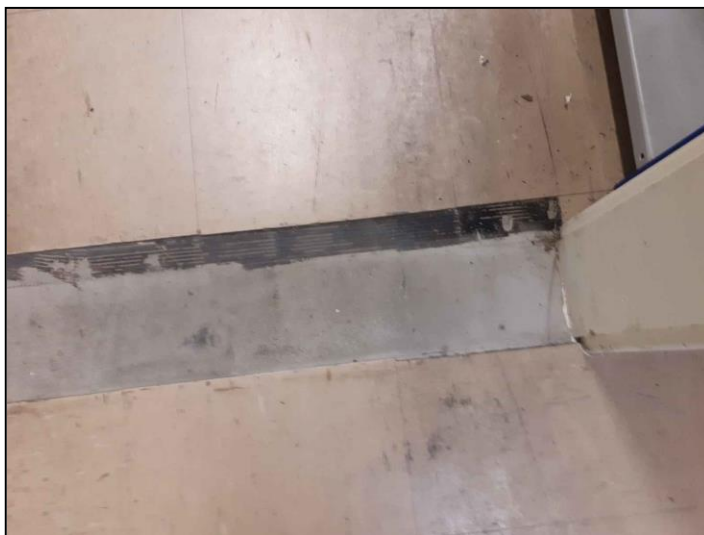
Asbestos Type: 0 - No asbestos detected

Sample No: 001

Approx Size of Item: 32 m<sup>2</sup>

Timescale for Recommendation : No action

Recommendation: No further action required

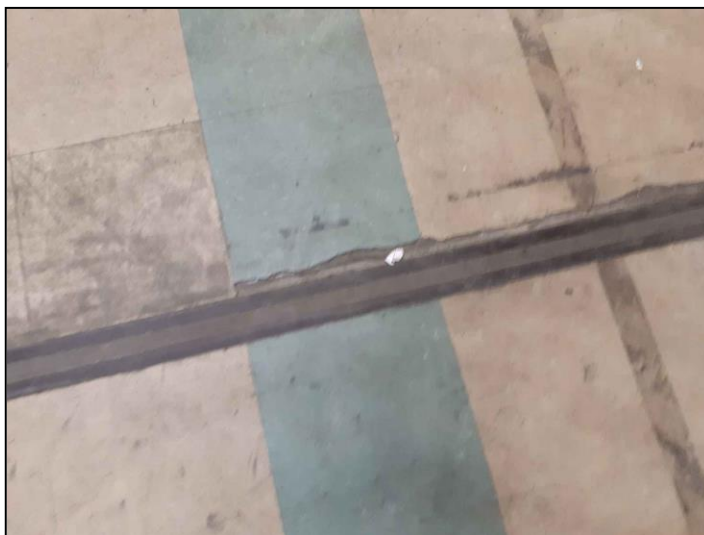
**Material Risk:** N/A  
**Asbestos Type:** 0 - No asbestos detected

**Timescale for Recommendation :** No action

**Recommendation:** No further action required
